Stainless Steel Industry  
Awards 2024

## Table of contents

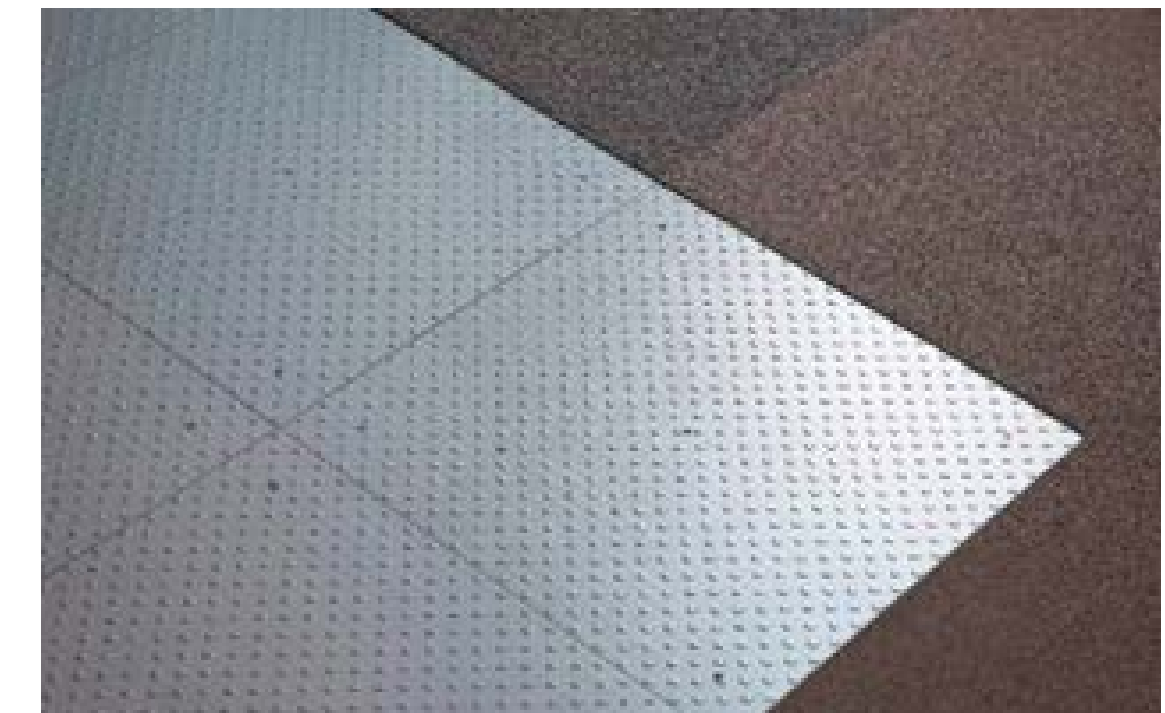
Figure 1: Appearances: round-dot pattern and checkerboard-pattern

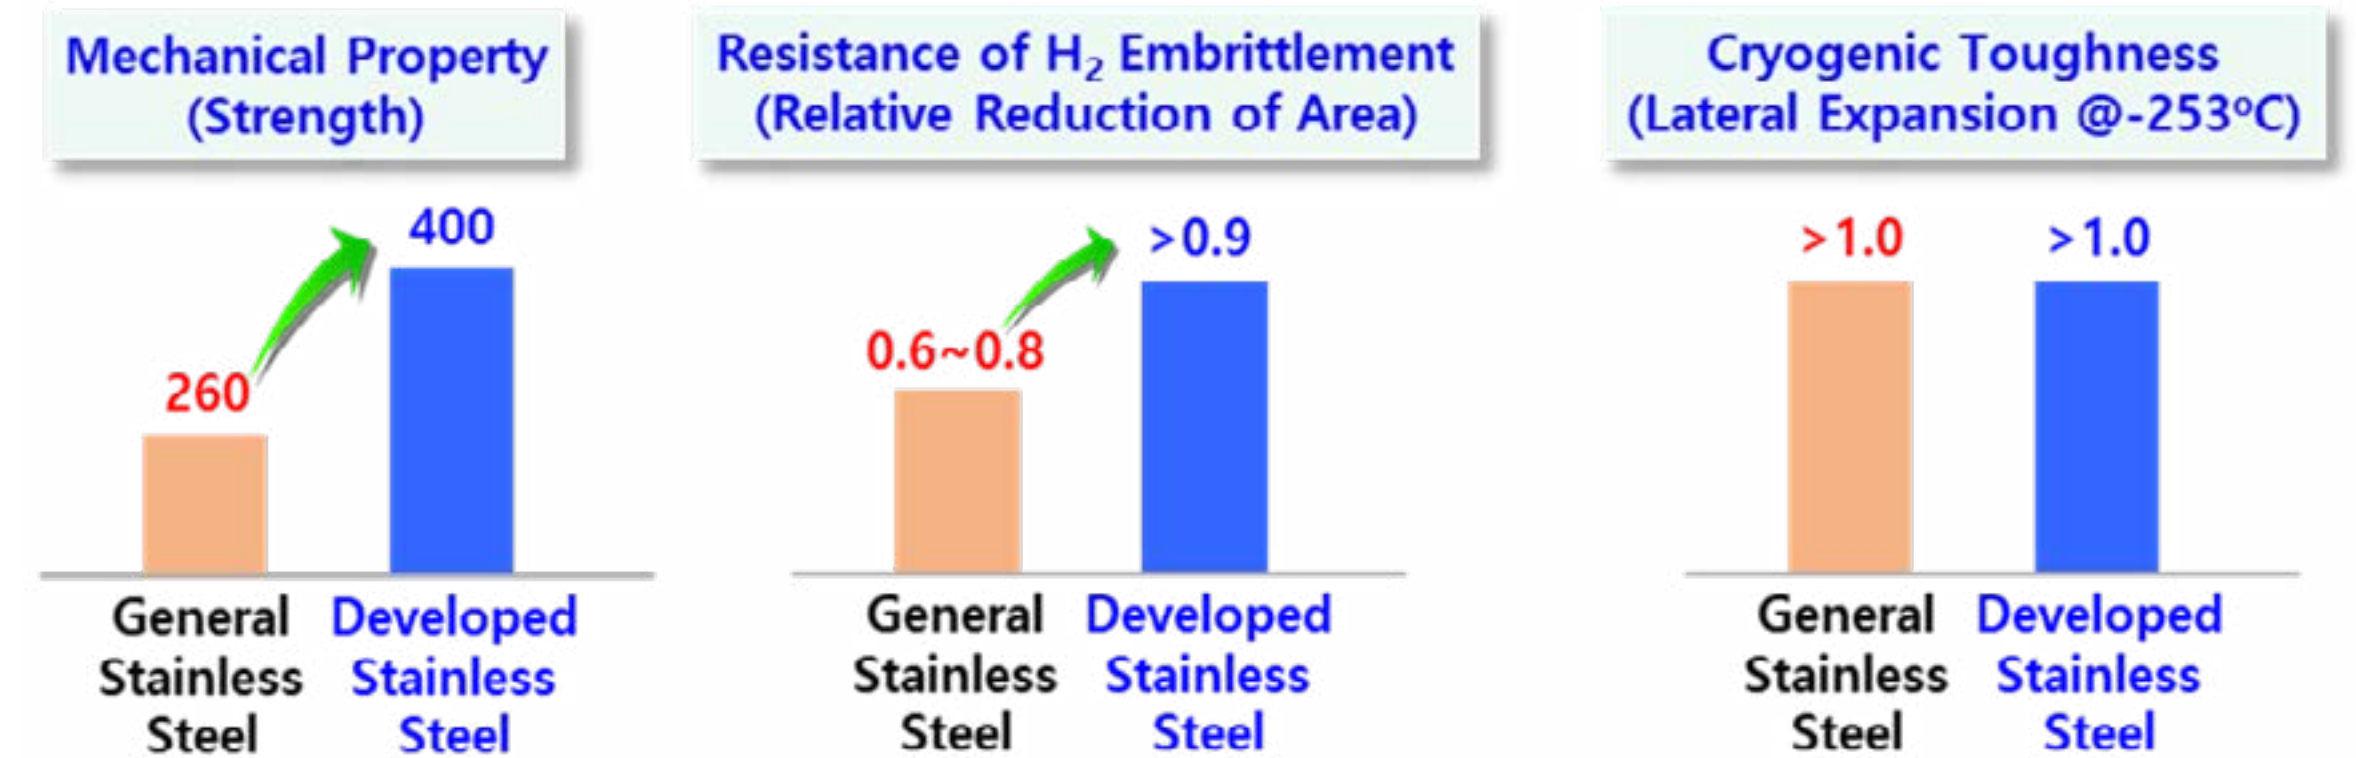
Mechanical property, Resistance of H<sub>2</sub> embrittlement, and Cryogenic Toughness of general and developed stainless steels

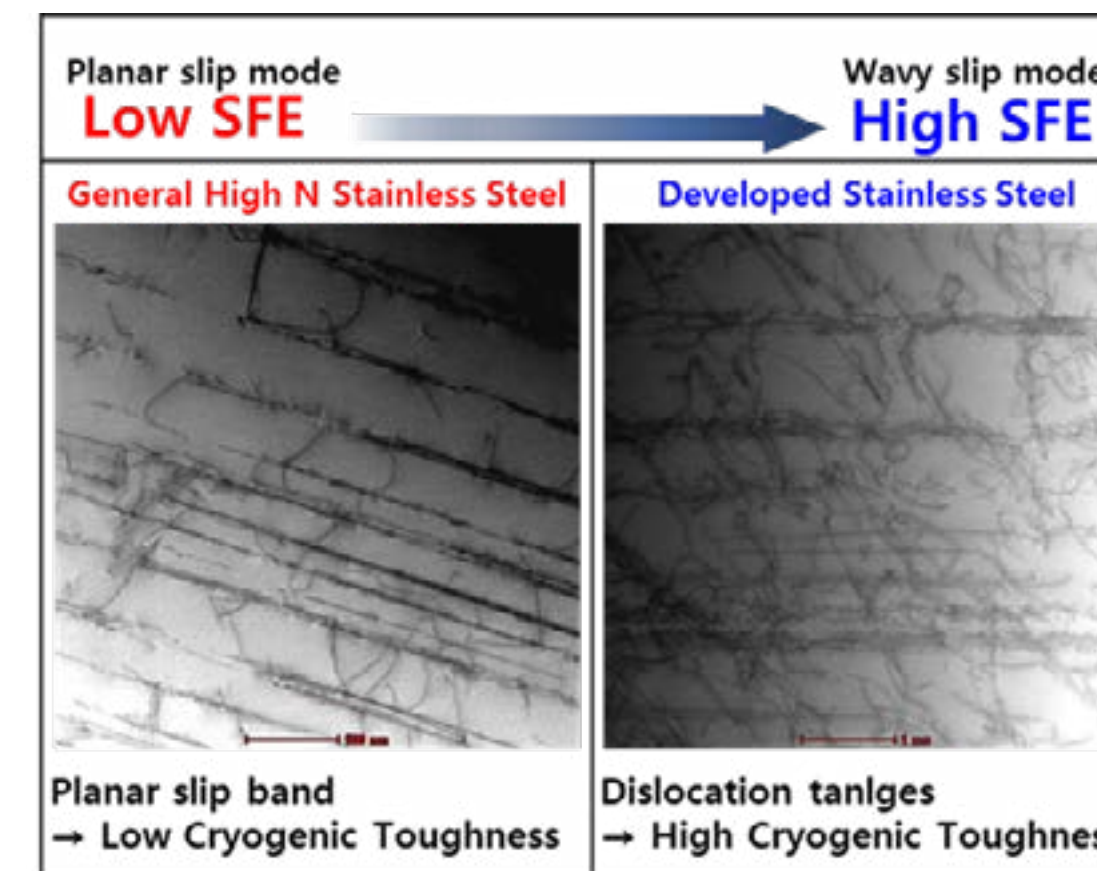
TEM image of general high N stainless steel and developed stainless steel

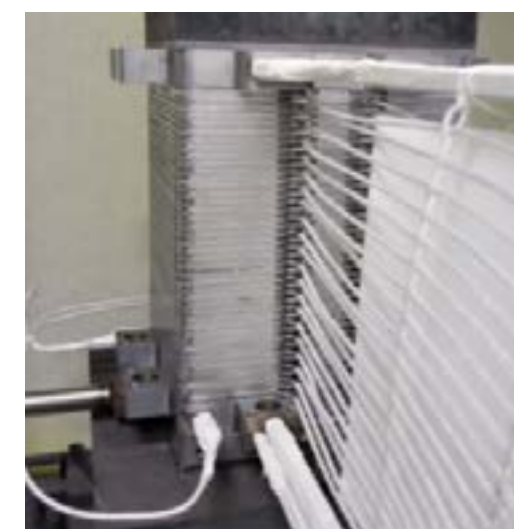
1KW SOFC stack with 460FC separator plates

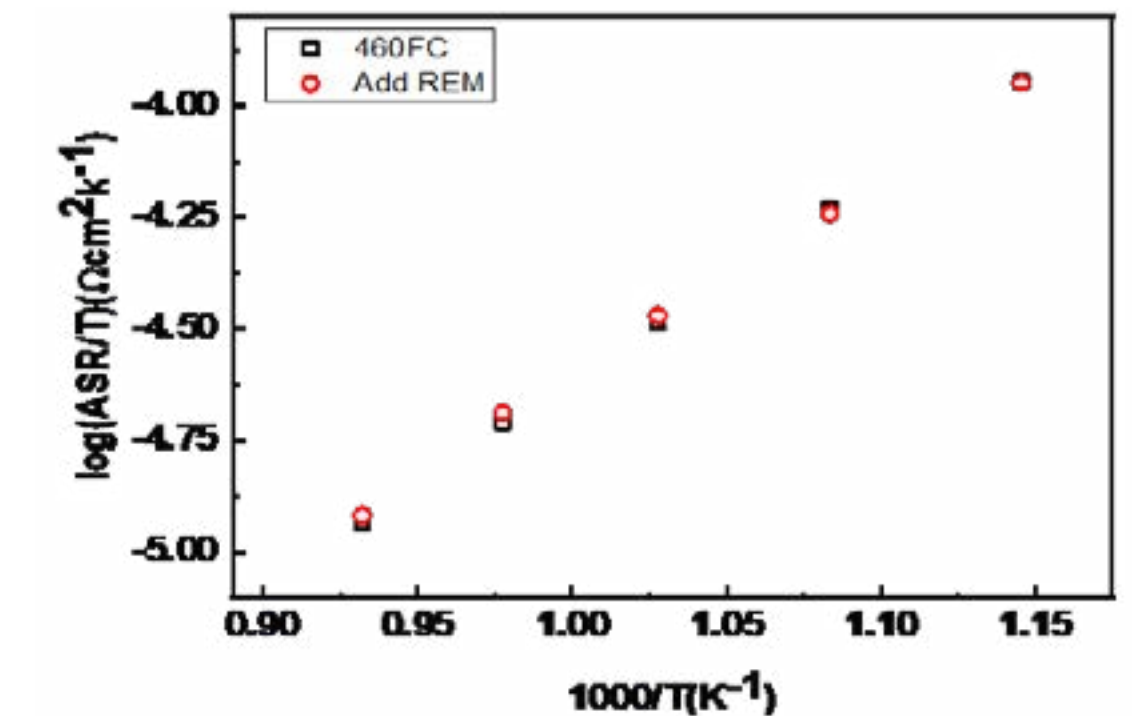
Temperature dependence of ASR after oxidation at 800°C for 500hrs in air

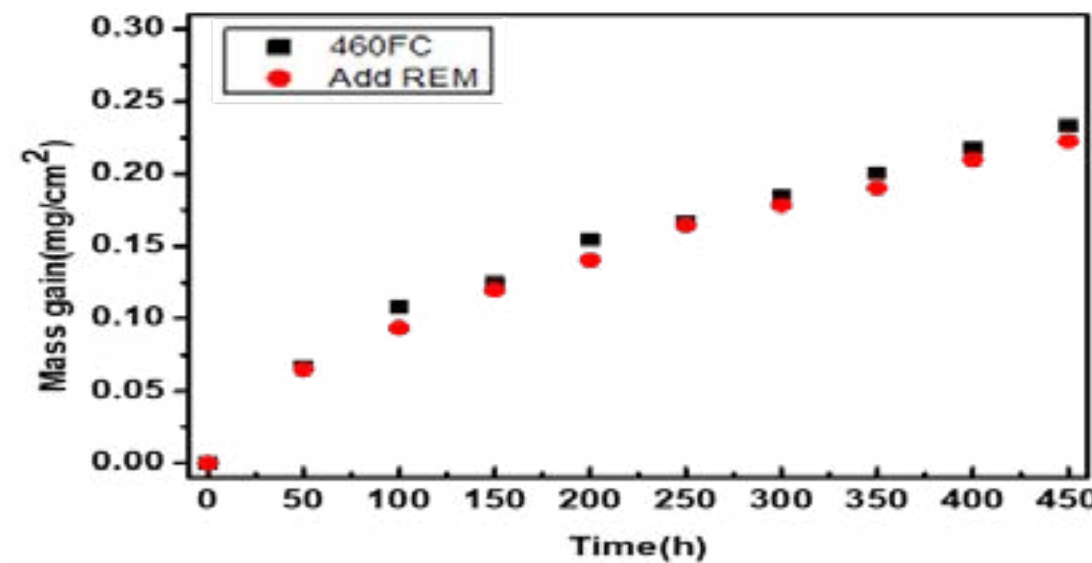
Mass gain of the sample at 800°C in air atmosphere

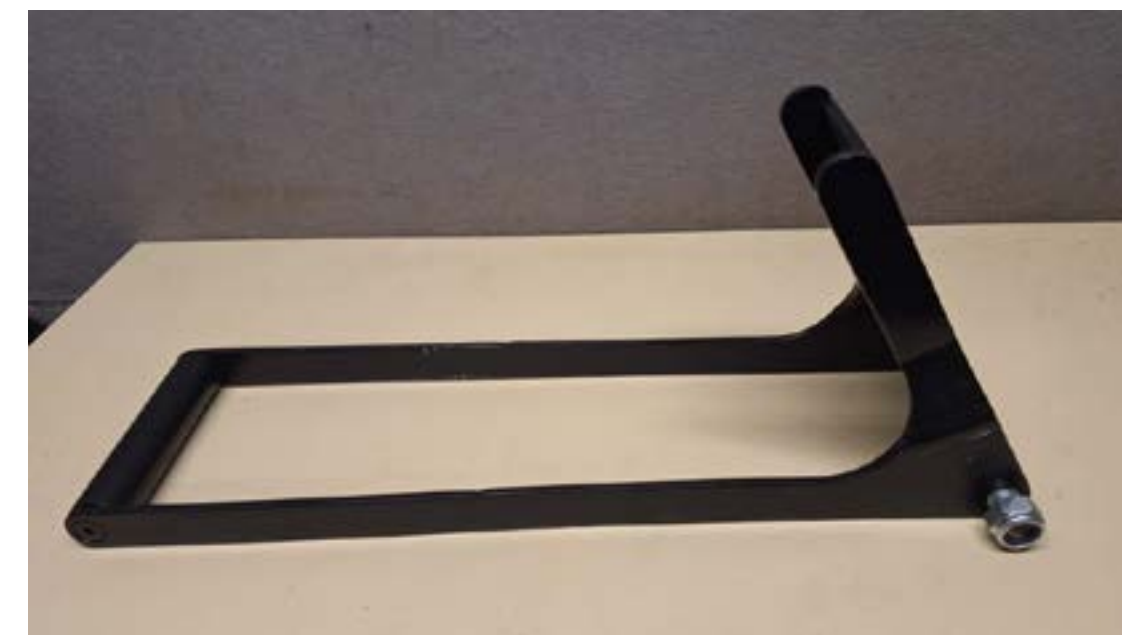
The latch was re-designed to allow the operator to open the latch by standing away from the "load path". The opening of the latch from behind the hook prevents the hand from nearing a nip point while the load is being attached to the hook.

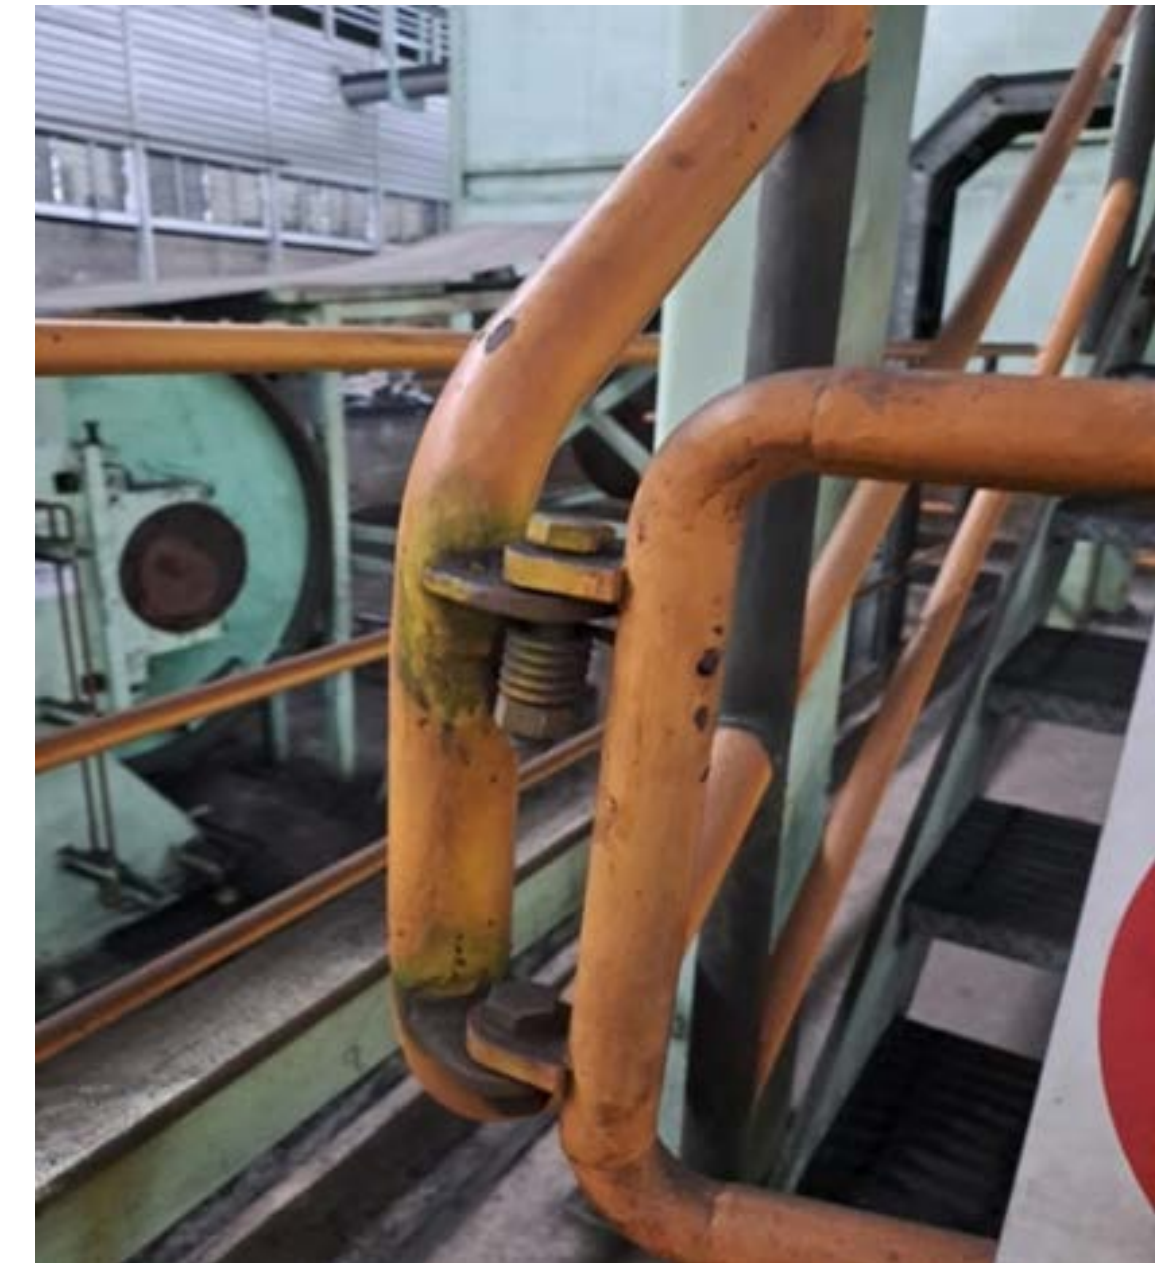
Spring Automated door closer

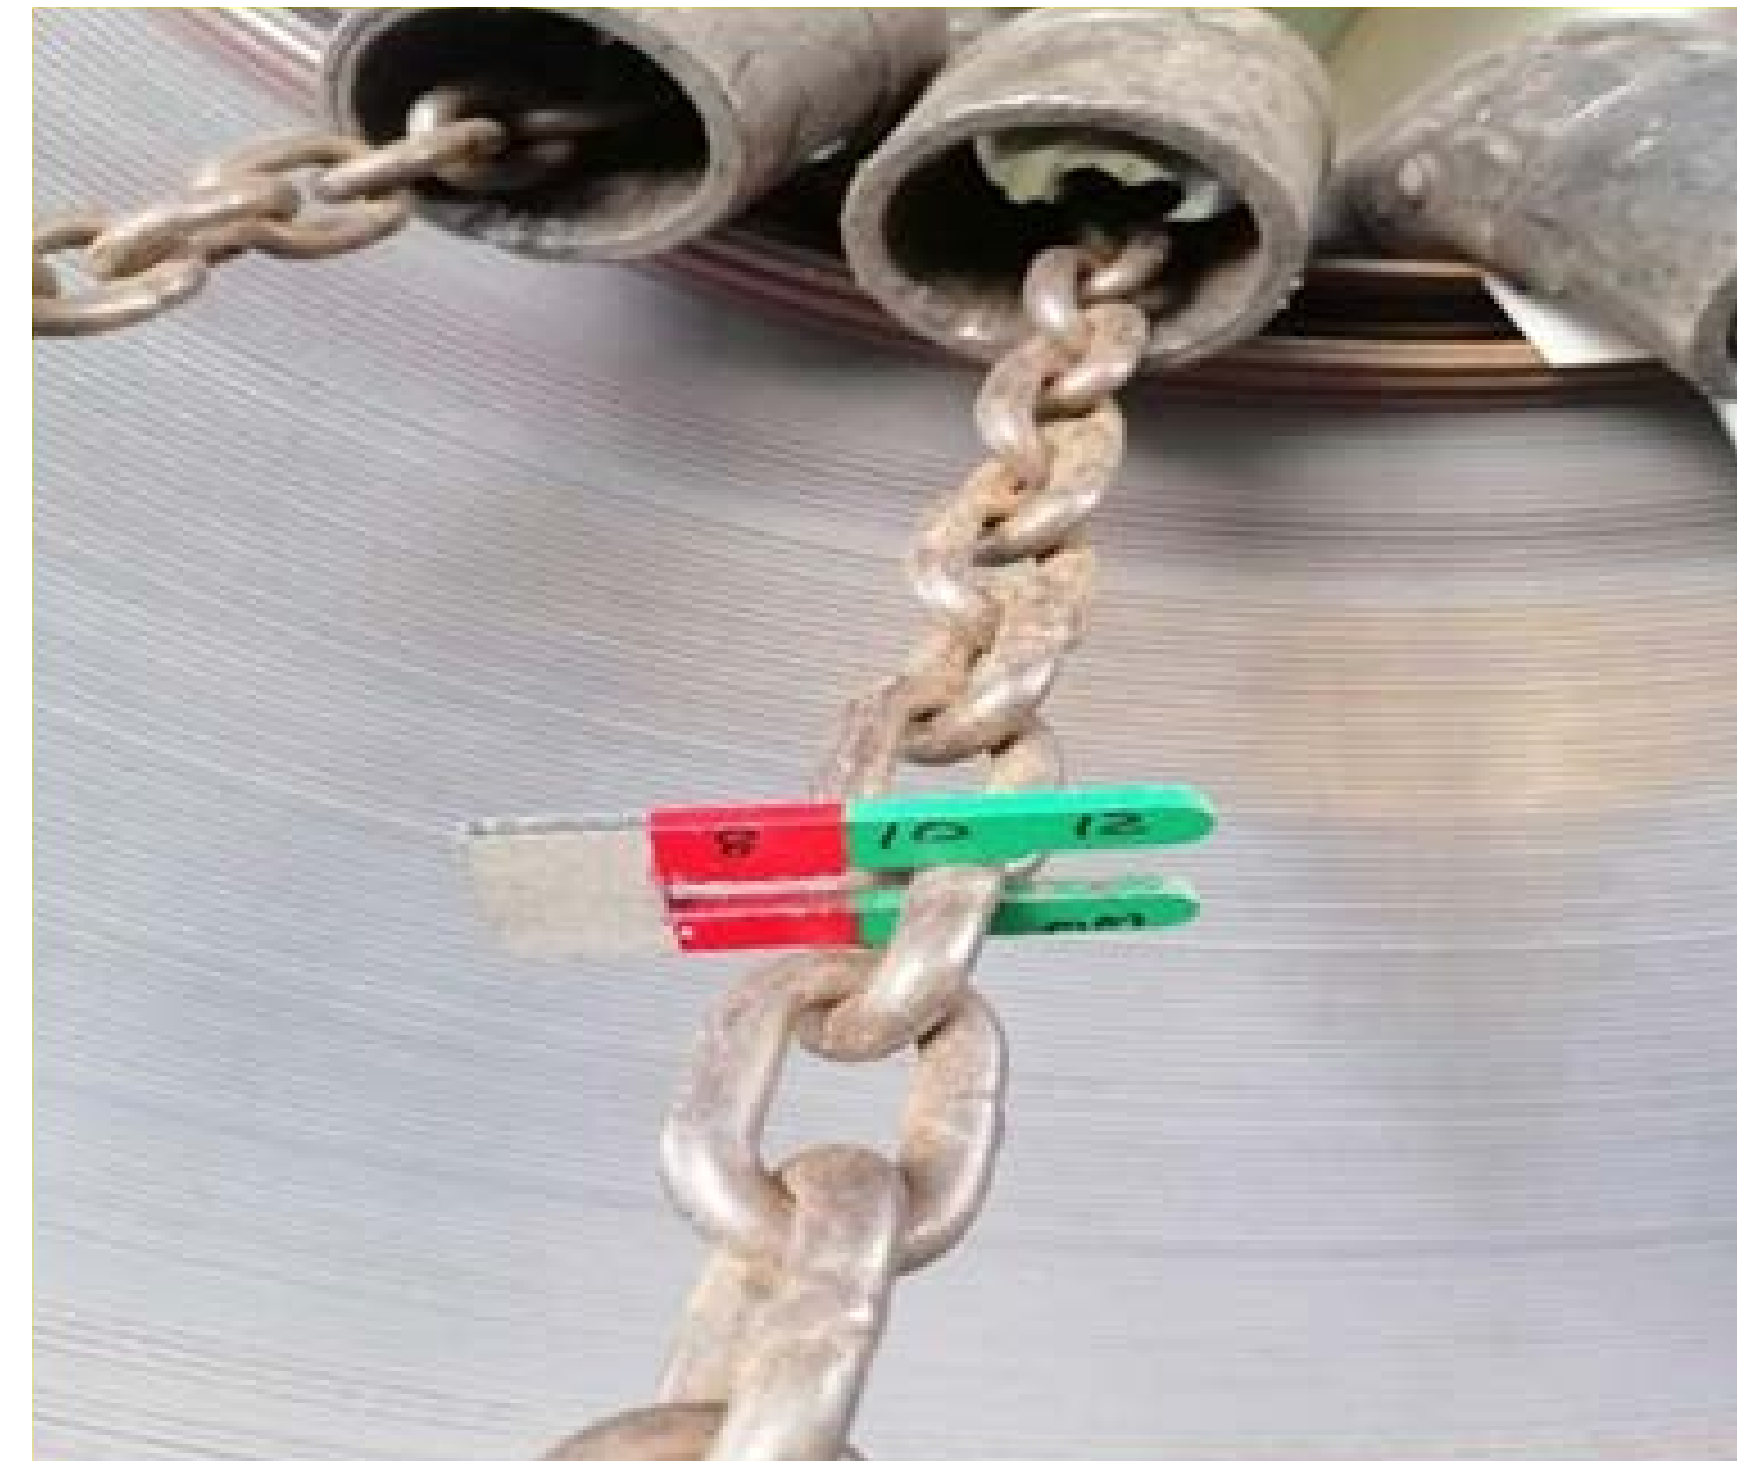
- The chain checker is marked with 8mm(Red), 10mm and 12mm (Green).
- If a chain is less than 10mm (Min

- As part of the final checks before a load can be dispatched from the Axle scale, the axle scale operator will inspect the chains diameter with the chain checker (Poka-yoke)

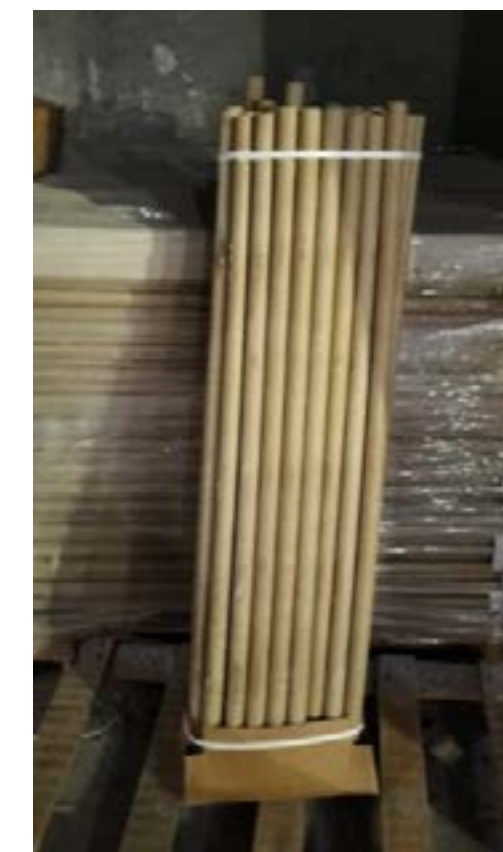
Fig. 1. Cardboard cartridges, which are used for the ignition of the thermal lances

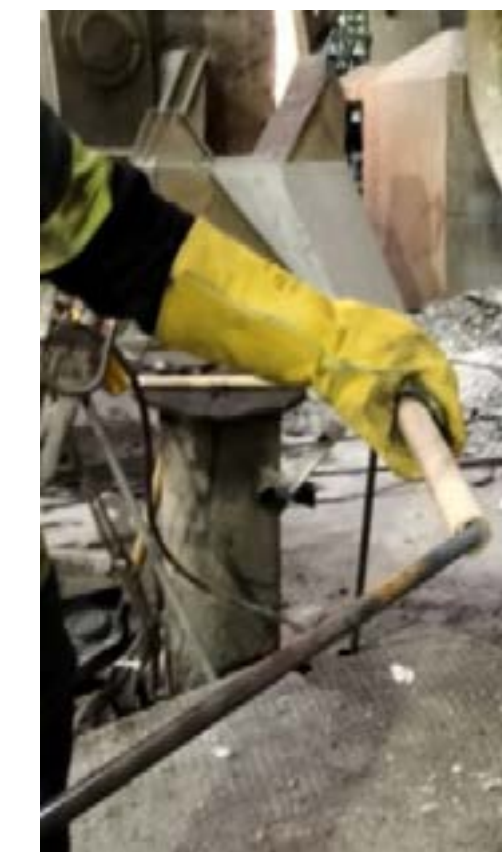
Fig. 2. Method of ignition prior to tool development. Risk of burns and contact with hot substances

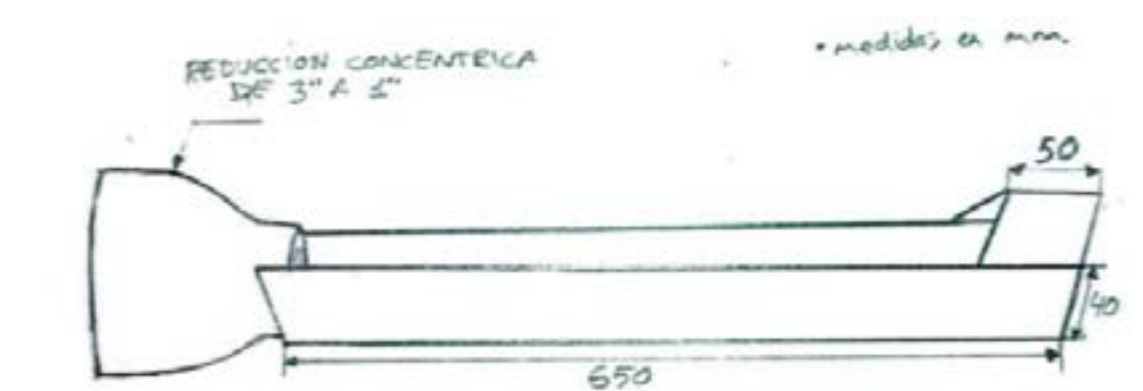
Fig. 3. Design of the tool (draw)

With the development and use of the new tool (Fig. 3, 4) designed specifically for this operation (Fig. 5), accompanied with the corresponding work procedure (Fig.6), the aforementioned risks are eliminated.

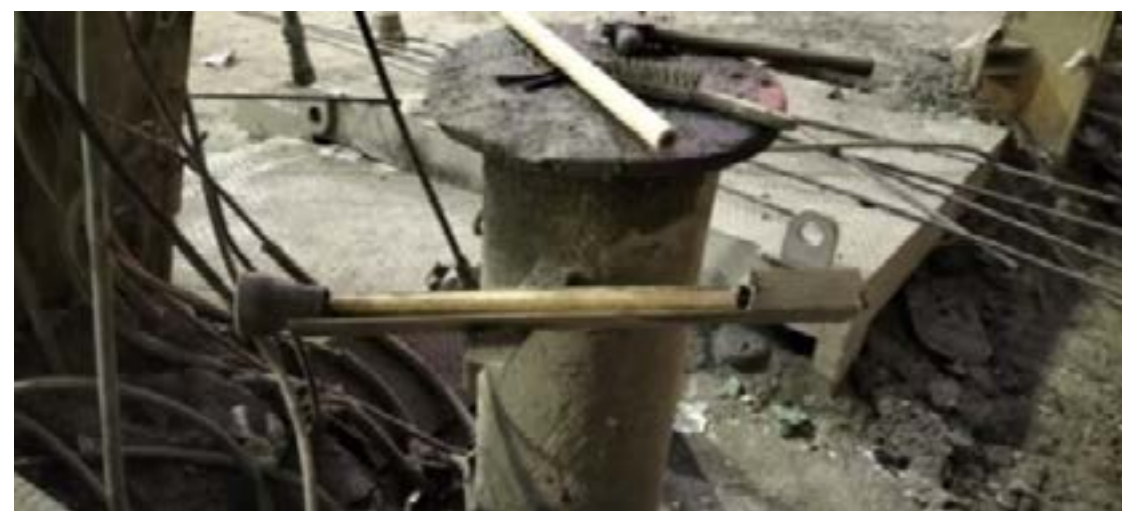
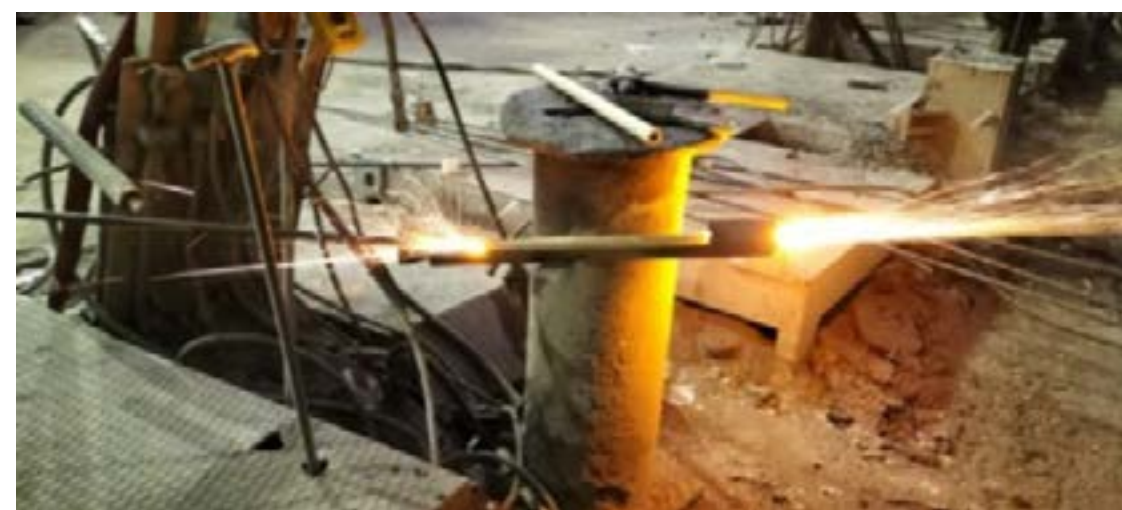
Fig. 5. New method developed for the ignition of the oxygen lances. This procedure avoid the risk of burns and contact with hot substances for the operators

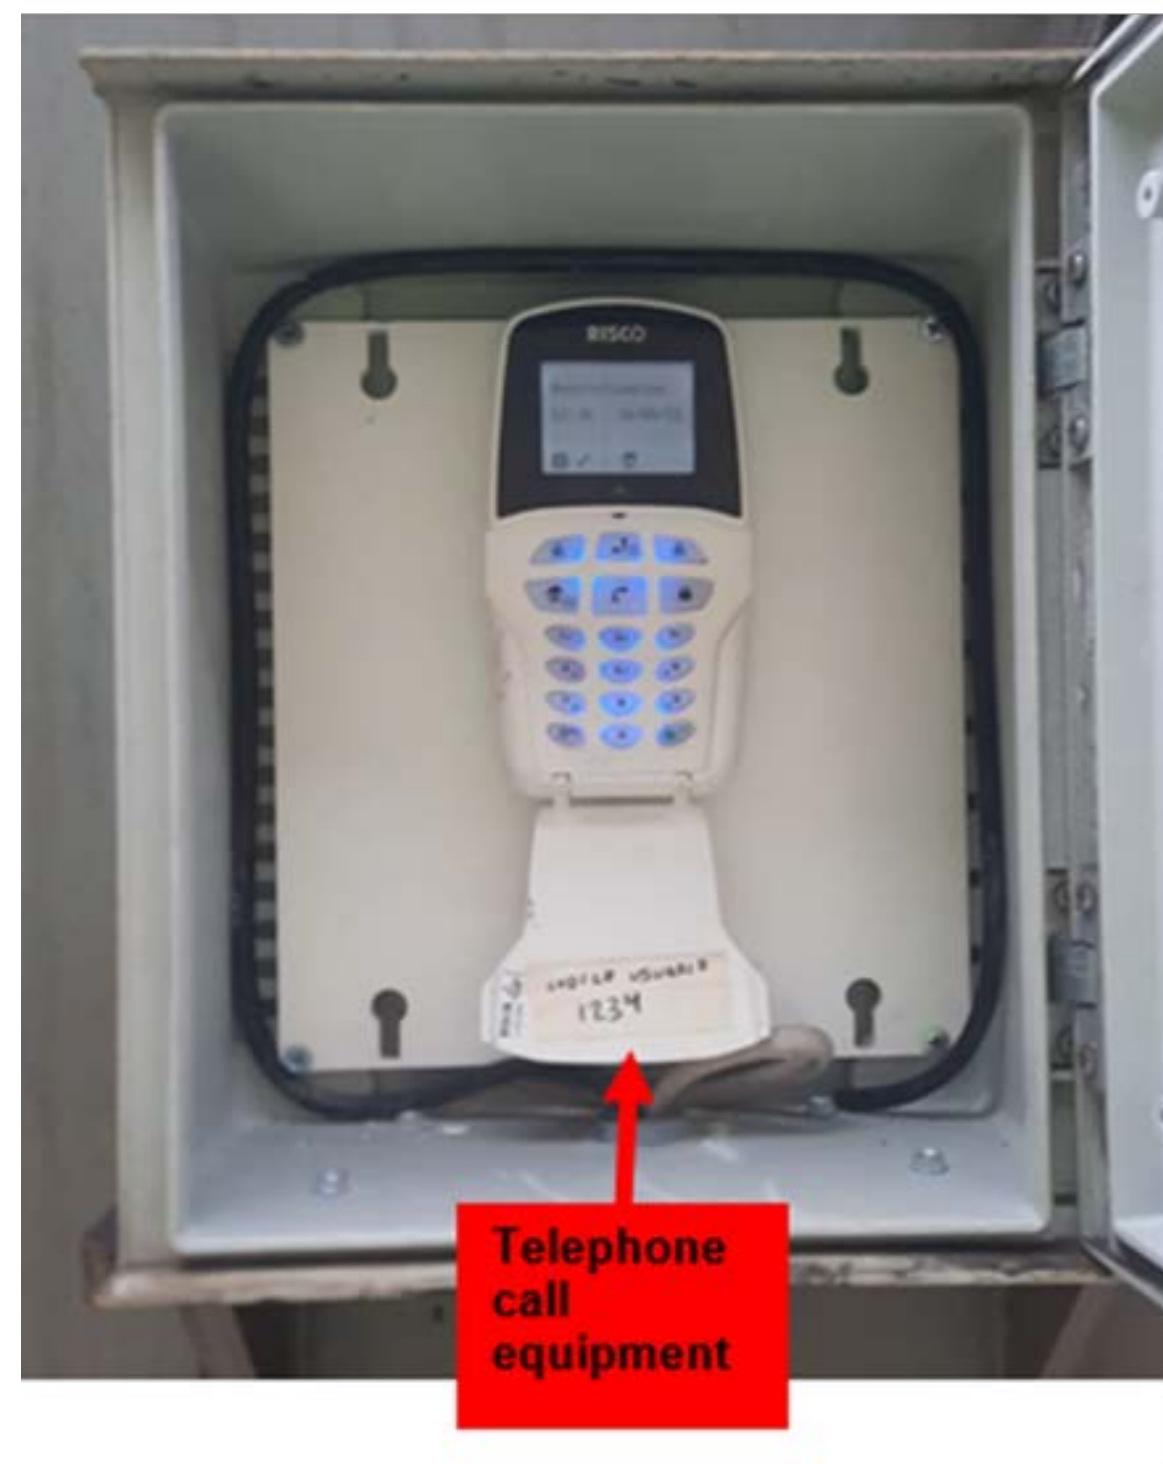
Fig. 2 Details of components in the decontamination cabin

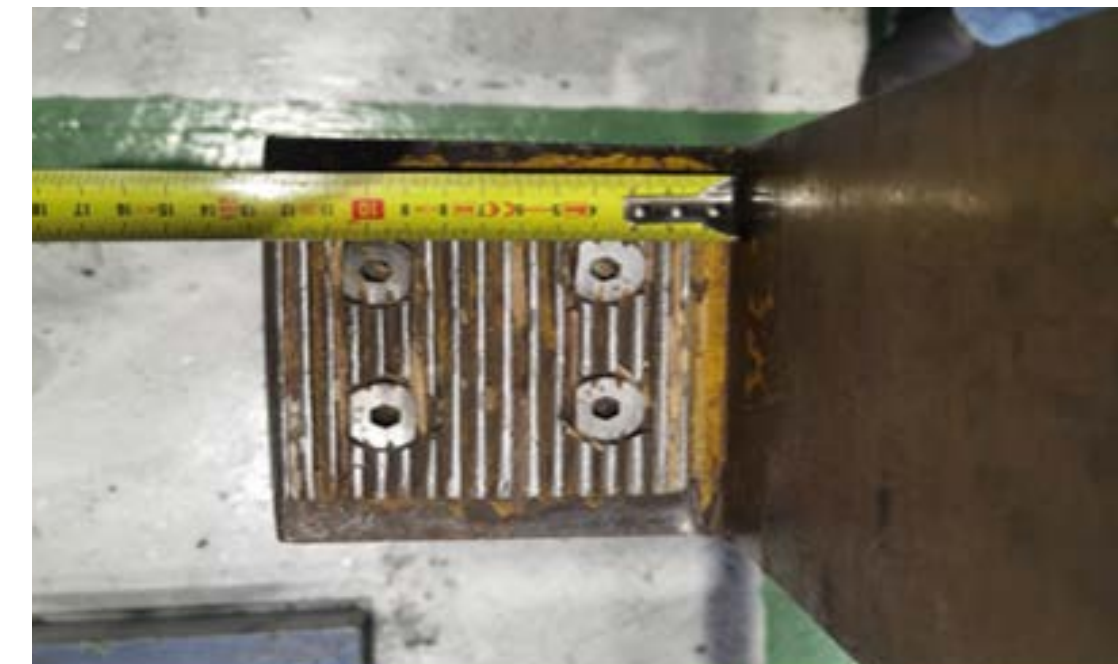
Feet before modification

- We have installed adjustable stoppers on all sides of the plate lifter to stop the material from shifting while being transferred from one area to another. We went further to extend the lifting feet of the lifter as well to keep the load more stable during transfer by overhead crane.
- The feet of the lifter were extended with 60mm. The original length was 130mm and the modified lifter feet are currently 190mm.
- See the pictures below for reference :

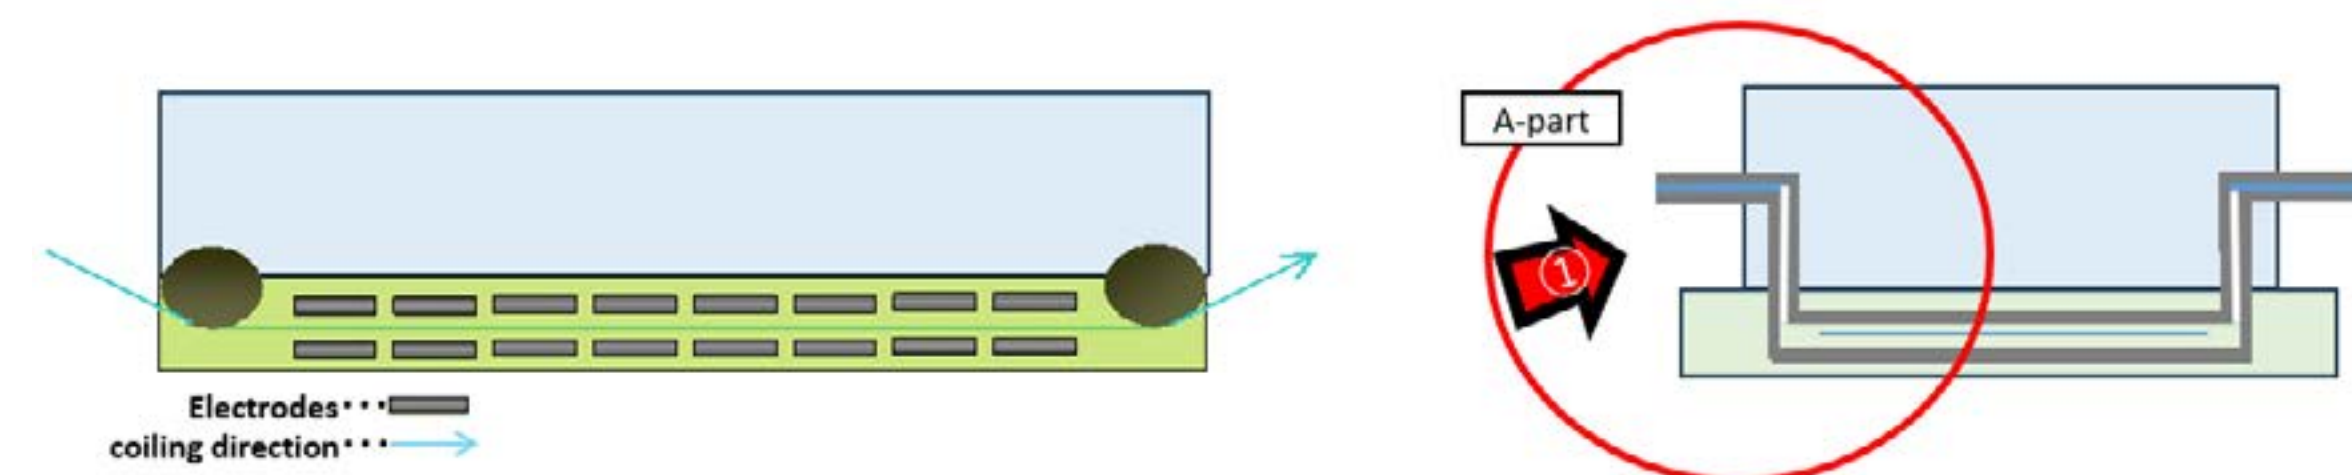
Figure 1: Cross section of sulfuric acid electrolysis tank

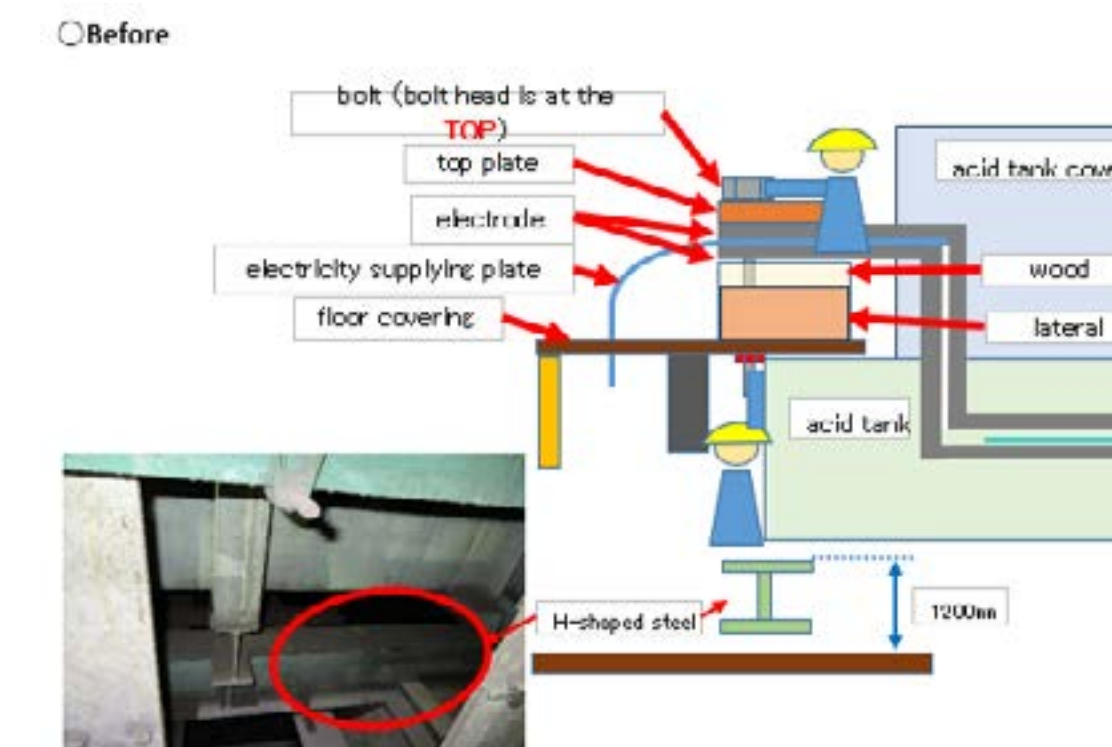
Figure 2: Before improvement (A-part in detail)

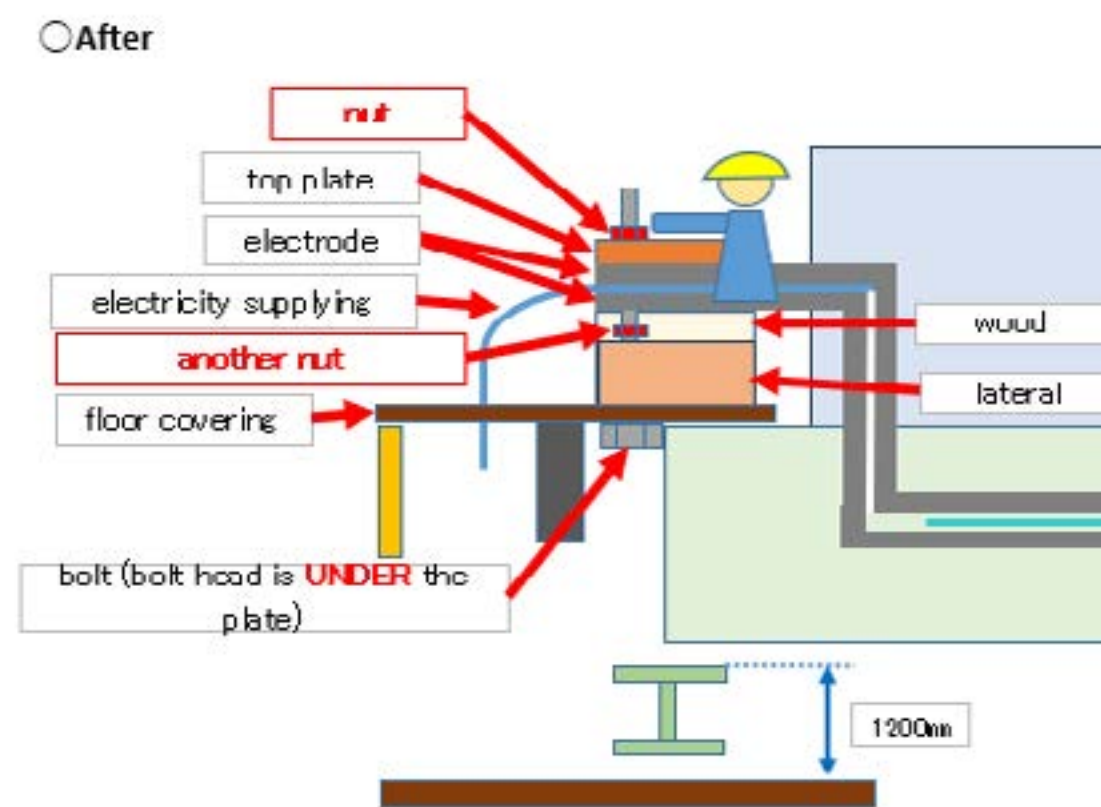
Figure 3: After improvement (A-part in detail)

Therefore, we thought of adding another nut on the lateral plate to prevent bolts from falling. With this method, the top plate and electrodes can be replaced by only removing the nut on the top plate,
